LAB REPORT

Unit ID **WIND ENERGY SYSTEM**
 Component **Wind turbine - main gear**
 Current sample number **1703568**

Manufacturer: **NGC**
 Oil brand name: **Mobil Mobilgear SHC XMP 320**

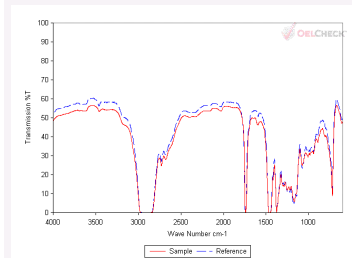
Infrared Spectrum

Iron has slightly increased. The additive value differs from the fresh oil value recorded in our database. Viscosity does not conform with the expected values. Possible reasons could be a different oil type or mixture with another oil type. The purity grade shows that the oil is significantly contaminated. I recommend that you change the oil as soon as possible if you have not already done so.
